## Overload Issue with 500-750W Sonicator

*If overloading when using a Microtip, please follow these instructions:*

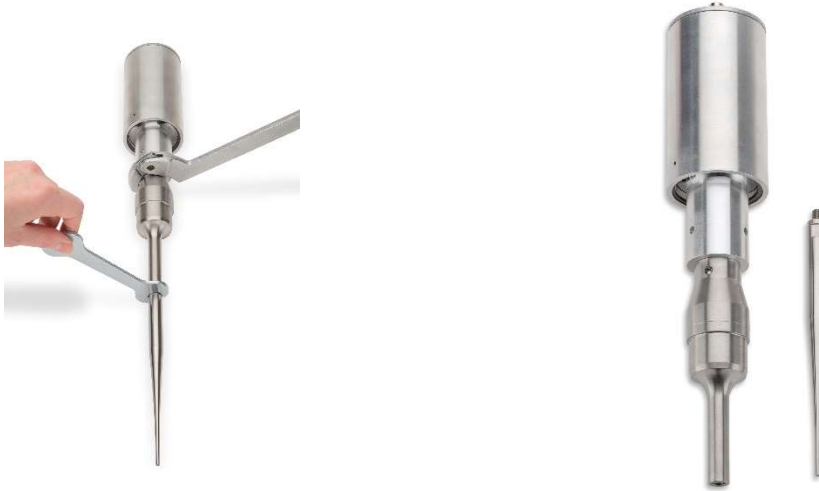
Most often the microtip is worn or damaged and needs to be replaced. To determine that the microtip is the issue and not another component, we must test the standard probe.

Remove the microtip:
