## EXAMPLES OF THE EFFECTS OF CAVITATION EROSION ON A PROBE TIP

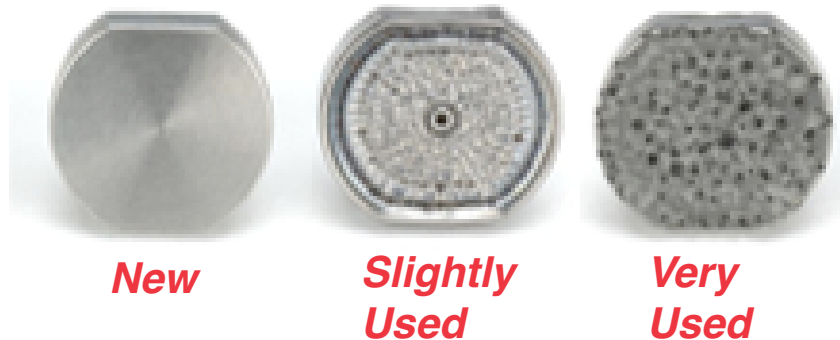
For that reason an ultrasonic probe tip should be periodically inspected for cavitation erosion. As the erosion progresses, first, the finish of the tip will change from its original polished appearance to a light gray and then to a darker grey, second, concentric circular rings will appear on the face of the probe tip, and then thirdly, the erosion will pit the probe tip to such a degree that it will have the appearance of a pumice stone. It should be noted that a highly eroded tip will not process a liquid effectively, as it will agitate the liquid rather than cavitate it, and will no longer have the ability to effectively transmit a high level of energy into the liquid.

When sonicating a liquid with ultrasonics, millions of shock waves, turbulent micro jet streams, and extremes in pressures and temperatures are generated near the tip of the probe and propagated to the surrounding medium as mechanical shear. It is this phenomenon, known as acoustic cavitation, that does the work. Cavitation also produces the undesirable and unavoidable consequence of eroding ultrasonic probes. When the probe erodes, microscopic residues are released from the tip into the liquid being processed (titanium migration), introducing impurities and potentially contaminating the liquid.
